**Preliminary Field & Lab Report**  
**DARBANDIKHAN LAKE POISONING EVENT**

September 2008  
Nature Iraq  
Sulaimani, Kurdistan, Iraq

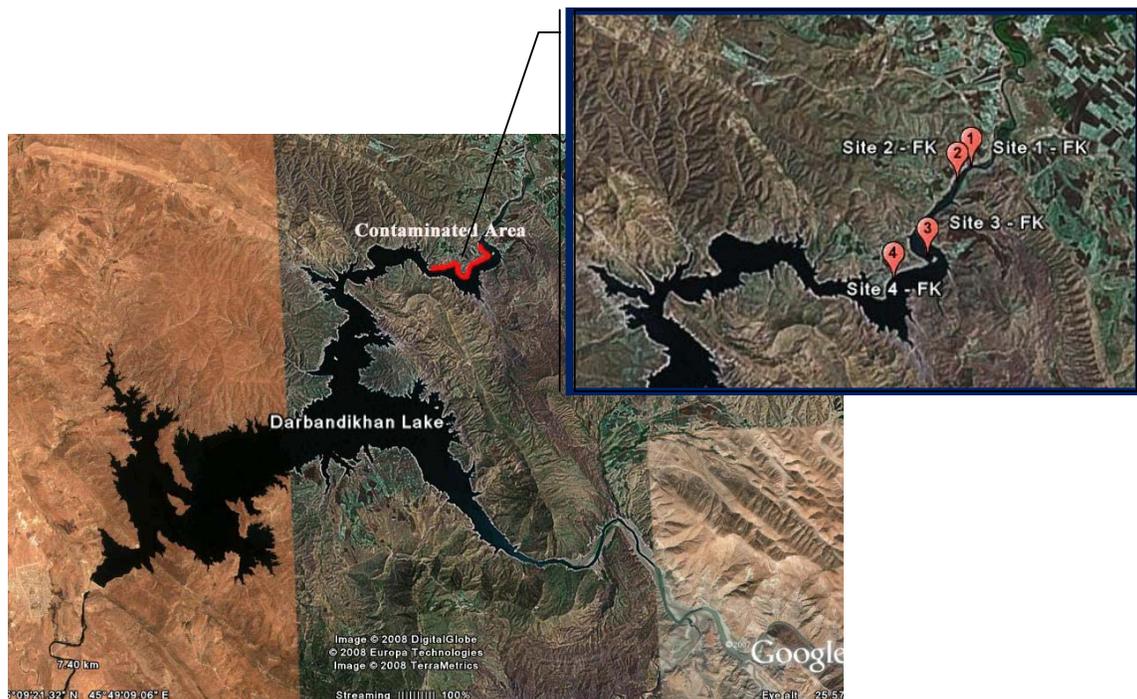
Plate 1: Map of Darbandikhan by Google Earth, showing area where contamination may have occurred and four sample points visited by this survey

A team from Nature Iraq went to investigate the situation on 13 August and when they arrived they found many dead fish and other creatures such as turtles as well as strong odours from the decaying organisms along more than three kilometres of the shoreline (This is indicated on the map above in red). It was estimated that more than one million fish were killed.

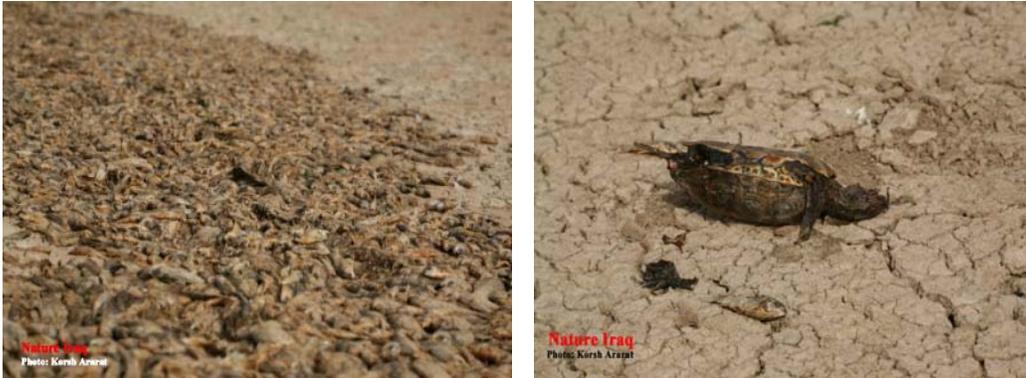
**Plate 2 & Plate 3: Photos from first Nature Iraq Site visit on 13 August**

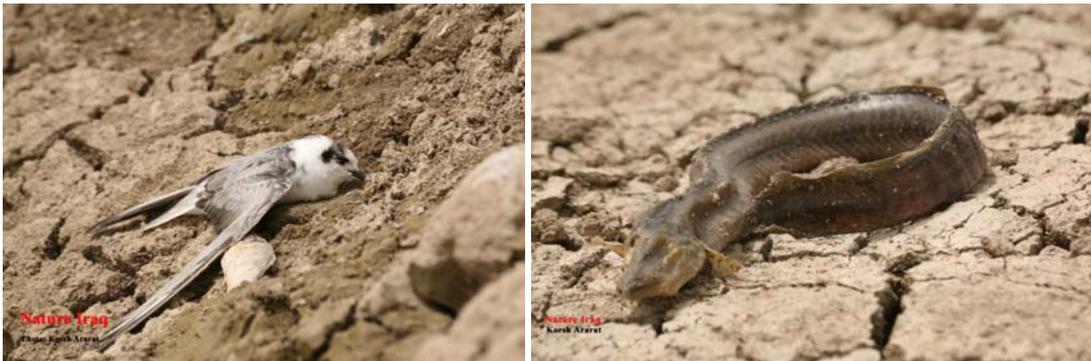
Then on 14th of August (the second day of investigation), Nature Iraq sent another team to investigate as well as take samples from the affected area. Site condition had deteriorated with more dead fish seen as well as a dead bird (see photos below). This is an indication of human-induced stress to the ecosystem.

**Plate 4 & Plate 5: Photos from second Nature Iraq Site visit on 14 August**
